# **AN ECOLOGICAL ASSESSMENT OF STREAMS IN GAITHERSBURG, MARYLAND: 2001-2002**

**November 2002**

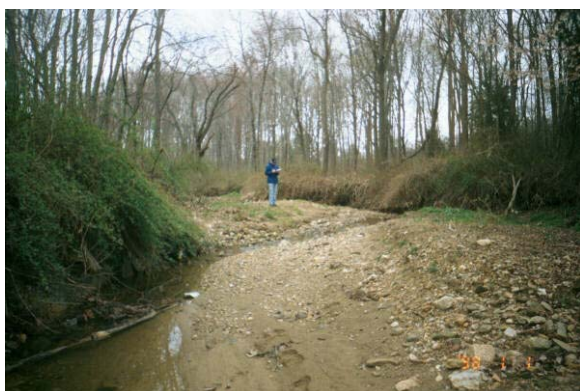
Figure 3-2

**Site Description:** Runoff via culvert from I-370 has blown out ephemeral channel, now 3m wide, 2m deep, and approximately 40m long (Figure 3-2). This has exacerbated meandering of Tributary 5 and led to extensive sediment deposition within channel. The meander belt is approximately 30m wide with 1m high terraces (Figure 3-3).

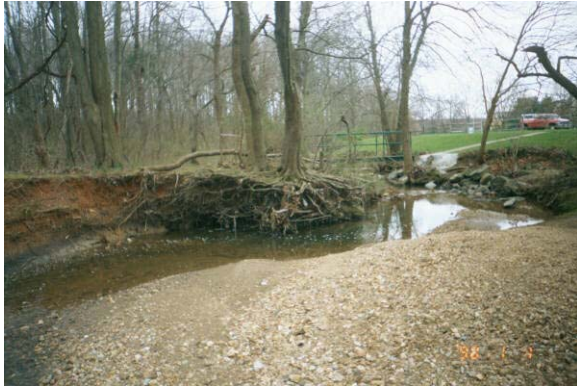
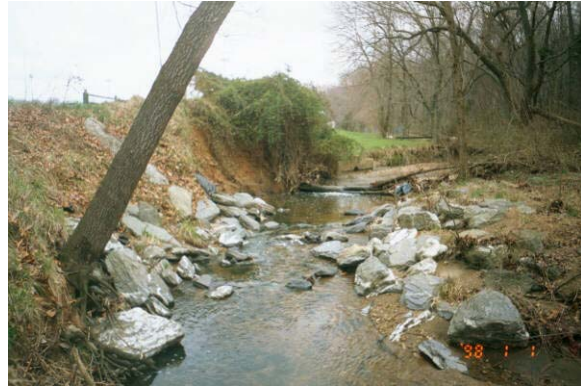
**Site No.:** MB-111  
**Site Score:** 64.50  
**Location:** Muddy Branch (upper), near Summit Hall Elem. School in Morris Park  
**Site Description:** Undercut streambank (30m long and 1m high) will soon topple a tree into the footbridge crossing the stream near Summit Hall Elementary School in Morris Park (Figure 3-4). Log in stream has created a plunge/scour hole immediately upstream of sewer line crossing, and 3m high, eroded bank.

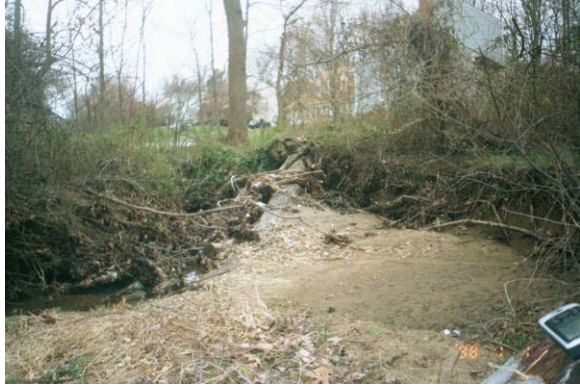
<b>Site No.:</b>	MB-114
<b>Site Score:</b>	64.00
<b>Location:</b>	Muddy Branch, tributary 5, Edgewood Ct.
<b>Site Description:</b>	Debris jam in stream 15m from house poses safety hazard, particularly during high flows (Figure 3-6). Tortuous bend in stream has formed extensive gravel bar and will continue to trap debris until meander bend is cut off (bank currently undercut and likely to fail within 2-4 years).

Figure 3-6	
<b>Restoration Approach:</b>	The large, fallen tree embedded in the gravel point bar should be left in place because it is trapping sediment, protecting the streambank nearest the houses, and aiding sediment transport through this bend. Smaller debris in the main channel should be removed. The undercut bank located across the stream and above the tree should be stabilized with riprap to prevent further erosion. Periodic inspections and maintenance should be conducted at this location to remove accumulated debris should it become a problem.

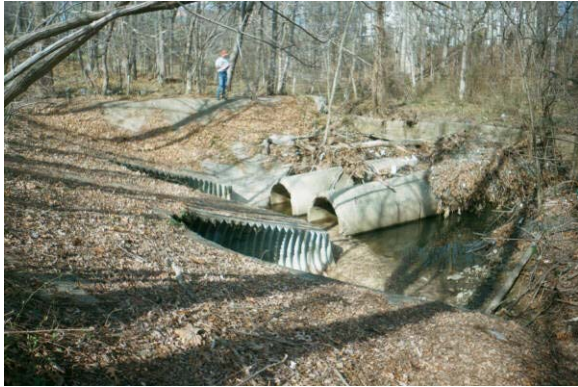
Figure 3-7

- Failed in-stream stormwater management structure between Noble Wood Ct. and Twelve Oaks Dr. has undermined gabion blankets, exposed pipes, and trapped large quantities of sediment, trash, and debris (Figure 3-7). This situation poses an extreme safety hazard.

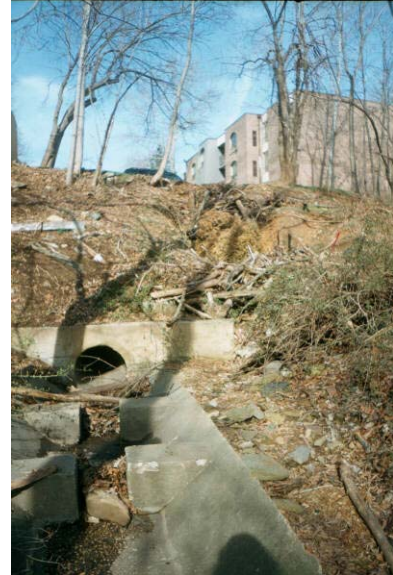
Figure 3-8

- Runoff from residential parking lot has bypassed outfall and eroded hillside (Figure 3-8).

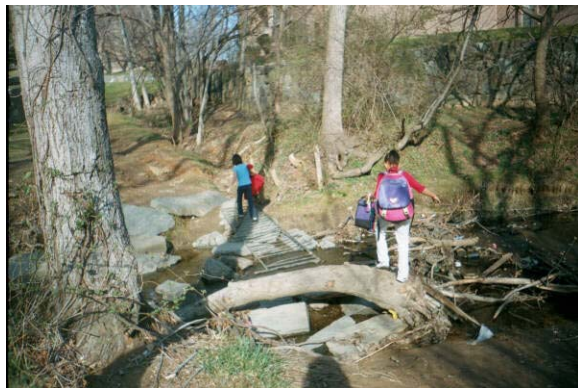
Figure 3-9

- Retaining wall of apartment building threatened by lateral stream channel erosion, and children using iron fence to cross stream in park immediately downstream from Clopper Road crossing (Figure 3-9). Nearby footbridge in park has been undermined by erosion (Figure 3-10).

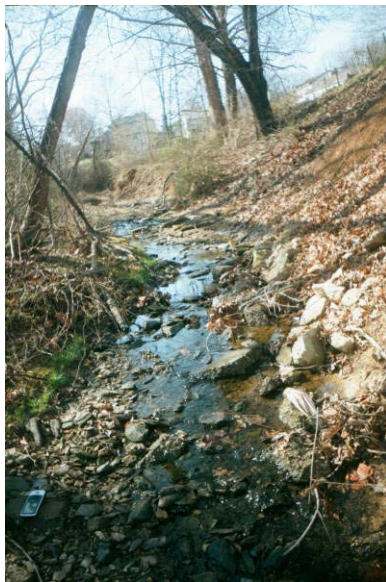
Figure 3-11

- Steep, eroded streambank behind houses on Melmark Ct. showed signs of active erosion (4m high banks located 10m from houses) (Figure 3-11). This erosion appears to be related more to a lack of vegetative cover and possibly an unstable angle of repose than from the adjacent stream. In any case, eroded sediment is likely to reduce water quality and stream habitat.

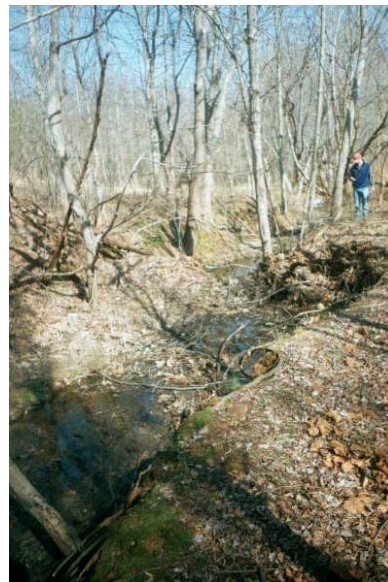
Figure 3-12

- Log dam near Seneca Creek State Park boundary is in disrepair and has a large scour hole below structure (Figure 3-12).
- Very large meander with scour and undercut banks will cut off bend (approximately 2-4 years) (Figure 3-13).
- WSSC sewer line encased in concrete acts as a dam/weir and blocks the stream channel at the confluence with Clopper Lake (Figure 3-14).

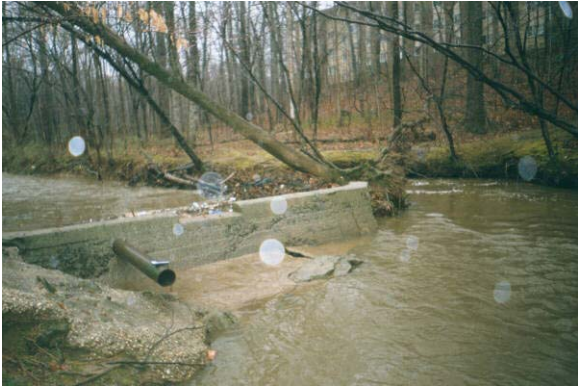
<b>Site Description:</b>	Erosion has end cut around a concrete weir (Figure 3-17). A logjam has formed between the new bank and the edge of the weir. Weir and logjam is located approximately 15m from an apartment building and presents a safety hazard.	
<b>Restoration Approach:</b>	The logjam and weir should be removed to allow for adequate transport of both water and sediment through the stream channel at this location. Following removal of the weir, stable channel dimensions, patterns, and profiles should be reestablished through this section. The banks should be stabilized with native vegetation, and riprap if necessary.	
<b>Approximate Cost:</b>	\$15,000 - \$30,000	Figure 3-17
<b>Site No.:</b> <b>Site Score:</b> <b>Location:</b>	GST-112 55.22 Great Seneca, tributary 1, near start of I-270 off ramp

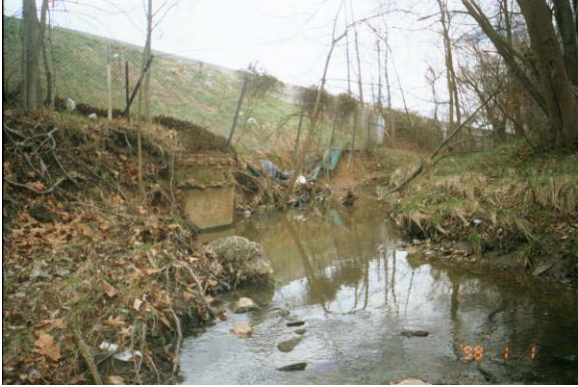
<b>Site Description:</b>	Bank erosion has exposed sewer manhole and has undermined fence, eroding approximately ½ m of road embankment (3m wide) (Figure 3-18). The stream is now approximately 9m from edge of the road.	
<b>Restoration Approach:</b>	Work with SHA to address eroded road bank issues at this location along I-270. At a minimum, the eroded road bank should be stabilized and the manhole should be protected from further lateral streambank erosion. This site could be stabilized by placing riprap around the exposed surfaces of the manhole to replace lost material and the eroded cut bank could be stabilized with vegetated riprap.	
<b>Approximate Cost:</b>	\$2,500 - \$5,000	Figure 3-18

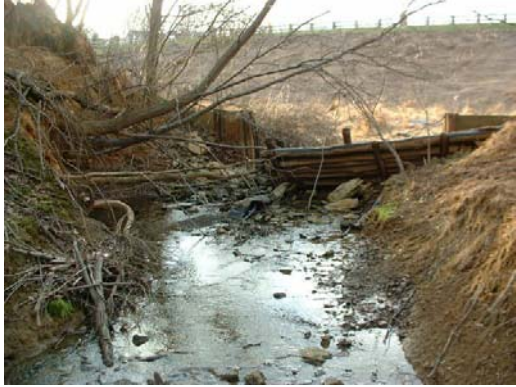
<b>Site No.:</b>	MB-104
<b>Site Score:</b>	55.00
<b>Location:</b>	Muddy Branch (lower), old breach in Lake Varuna at Lakelands Drive
<b>Site Description:</b>	<p>A breach in the man-made berm of Lake Varuna caused by Hurricane Agnes in 1972 appeared to have been temporarily fixed with a log and plank wall covered with erosion control fabric (Figure 3-19). The channel has end cut around this temporary dam, eroding the berm and causing the dam to fail. The proximity of this site to the nearby residential community is a potential safety hazard. Restoration of this site also presents a good opportunity to provide additional flow control that can help to protect the downstream channel from further stormwater impacts.</p>

<b>Restoration Approach:</b>	<p>At a minimum, the dam structure should be removed from this location. The inner slopes of the berm at the breached location should also be stabilized with geogrid and vegetation to prevent further erosion and subsequent sediment deposition into the stream. The potential opportunity for a stormwater retrofit structure at this location should also be examined. For example, a new structure could be built at this location to provide both water quantity and water quality benefits.</p>
